UNITED STATES DISTRICT COURT
FOR THE EASTERN DISTRICT OF NEW YORK

ALEX MOUSSAVI, P.E., being duly sworn, deposes and says that:

6. On February 5, 2015, I performed a structural inspection of the property located at 490 MacDonough Street, Brooklyn, NY 11233. The purpose of the inspection was to evaluate the major systems of the building such as foundation, structure, heating system, electrical system, plumbing system, roofing, exterior siding, the interior rooms and specifically the ground level apartment. A report of my findings, which I hereby certify as accurate, is attached hereto as Exhibit "B".

Subject: 490 MacDonough Street, Brooklyn, NY 11233
Report# 609709

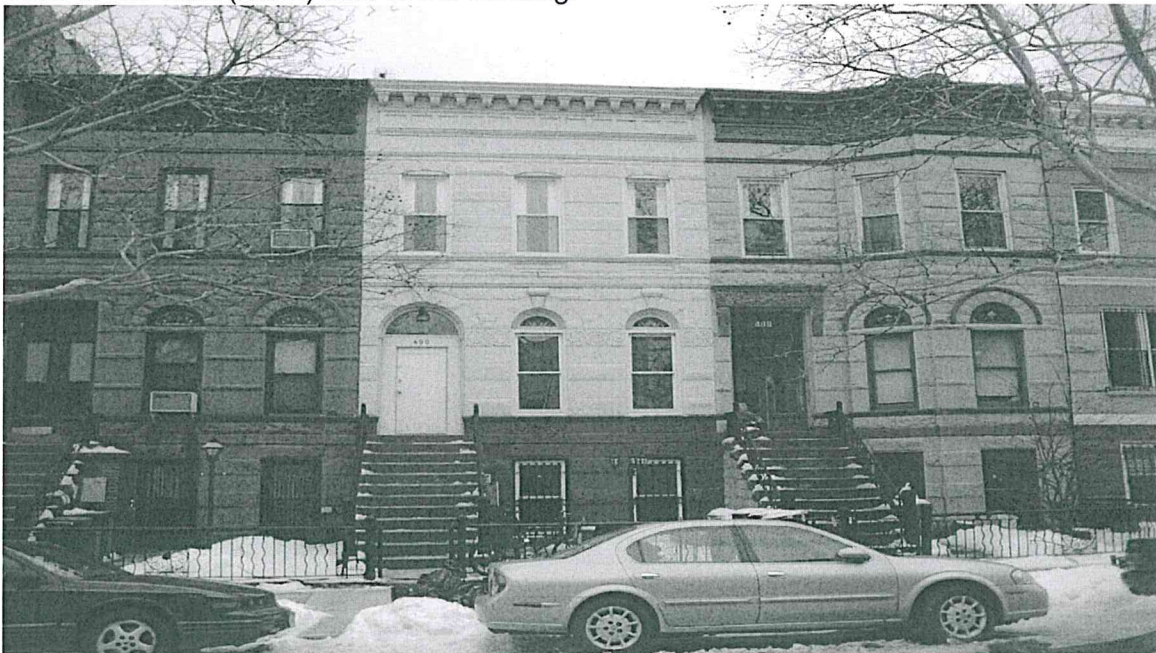
Photo 1

View of the front (north) side of the building.

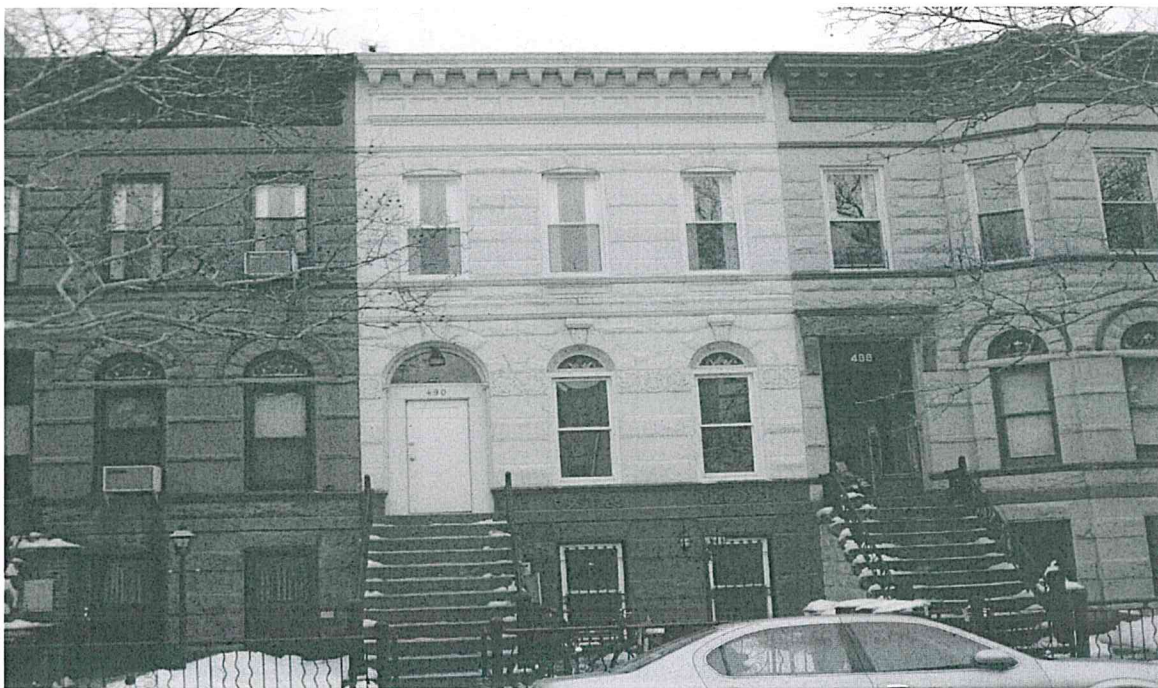
Photo 2

View of the front (north) side of the building.

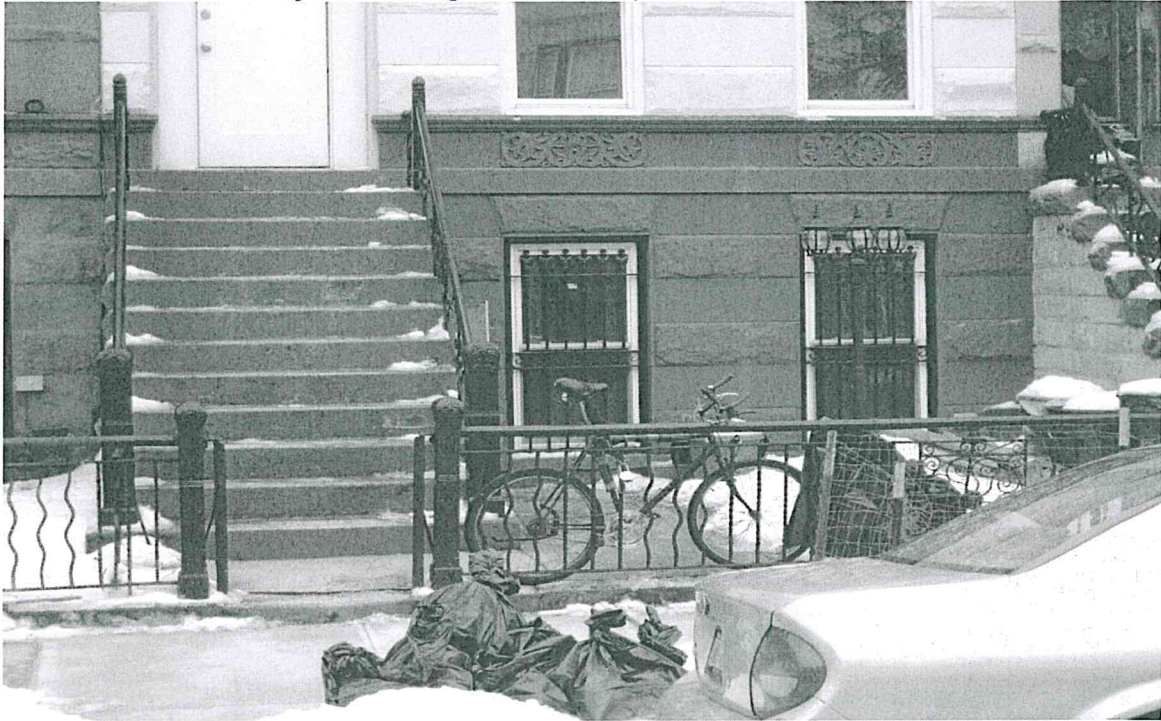
Photo 3

View of the exterior façade of the ground level apartment.

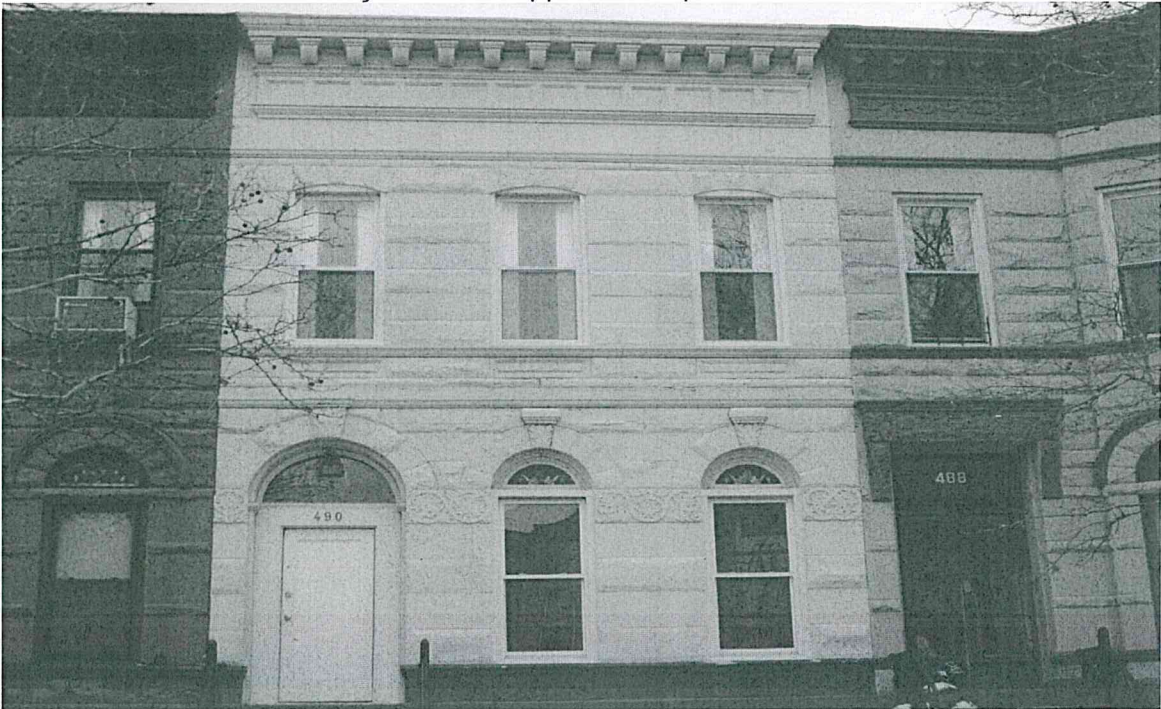
Photo 4

View of the exterior front façade of the upper level apartments.

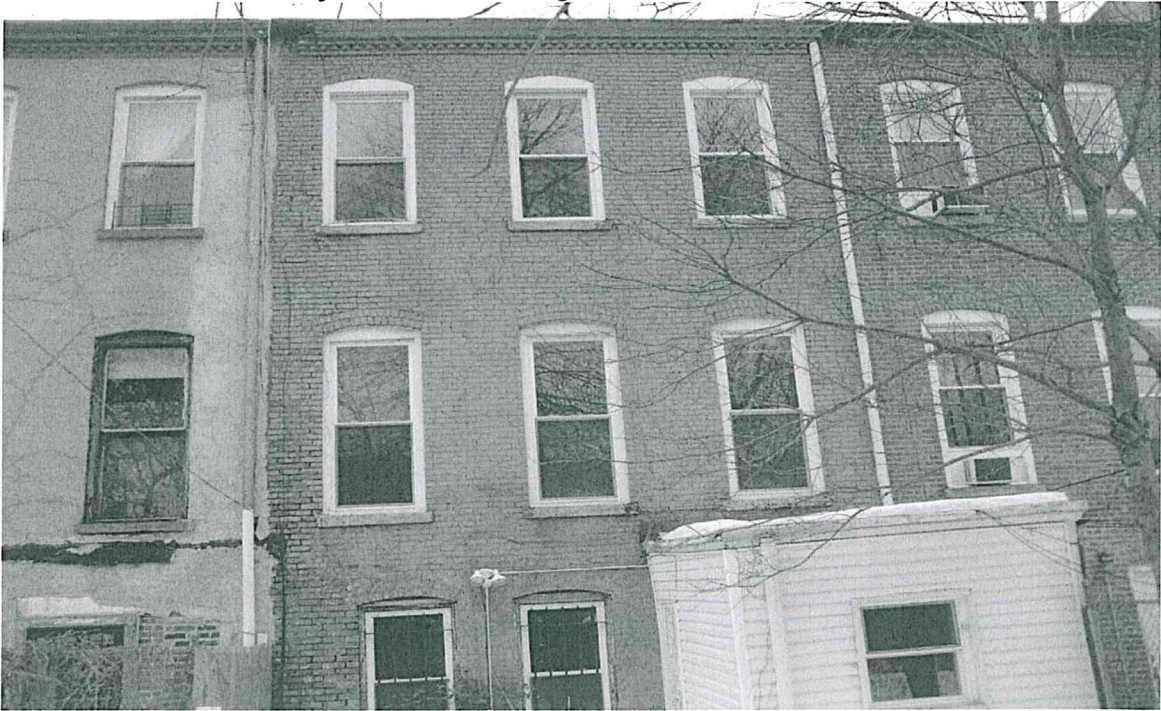
Photo 5

The front façade of the building was brownstone material and in satisfactory condition. The rear façade of the building was brick material. We inspected the front and rear façade. We observed cement mortar deterioration at the joint of the bricks. The front brownstone façade was found to be in overall satisfactory condition. The cement mortar between the bricks of the rear brick façade was deteriorated at sections. Plan to repoint the rear brick façade.

View of the rear brick façade of the building.

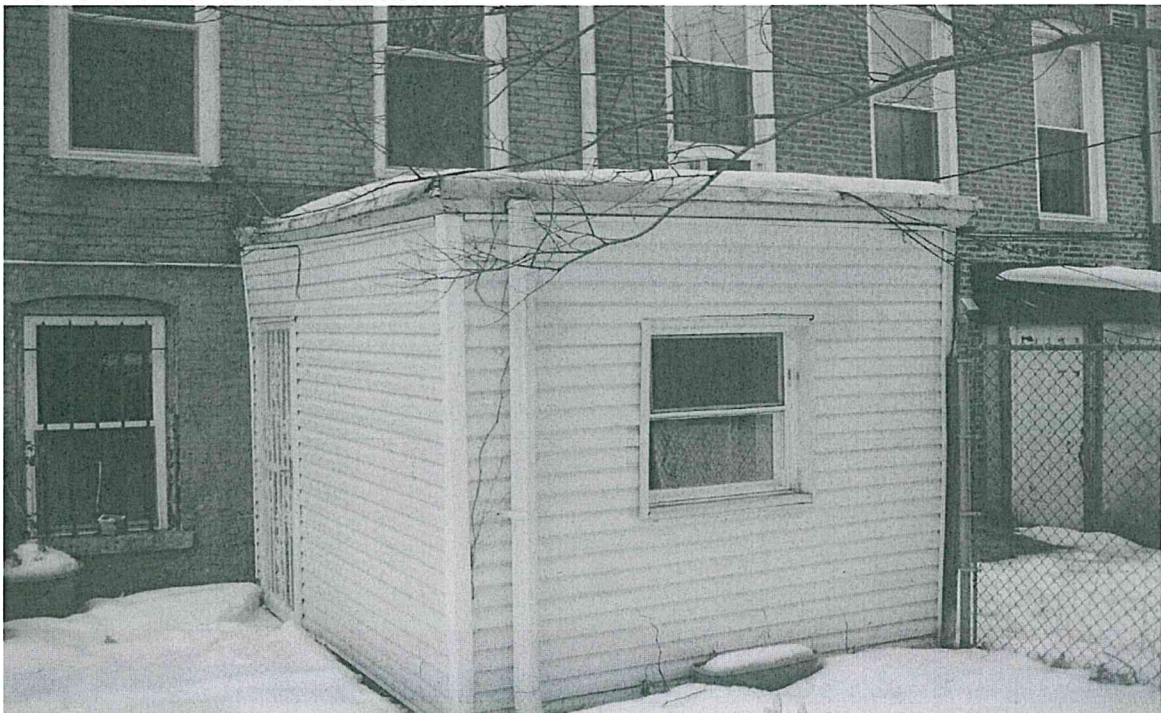
Photo 6

View of the rear kitchen extension.

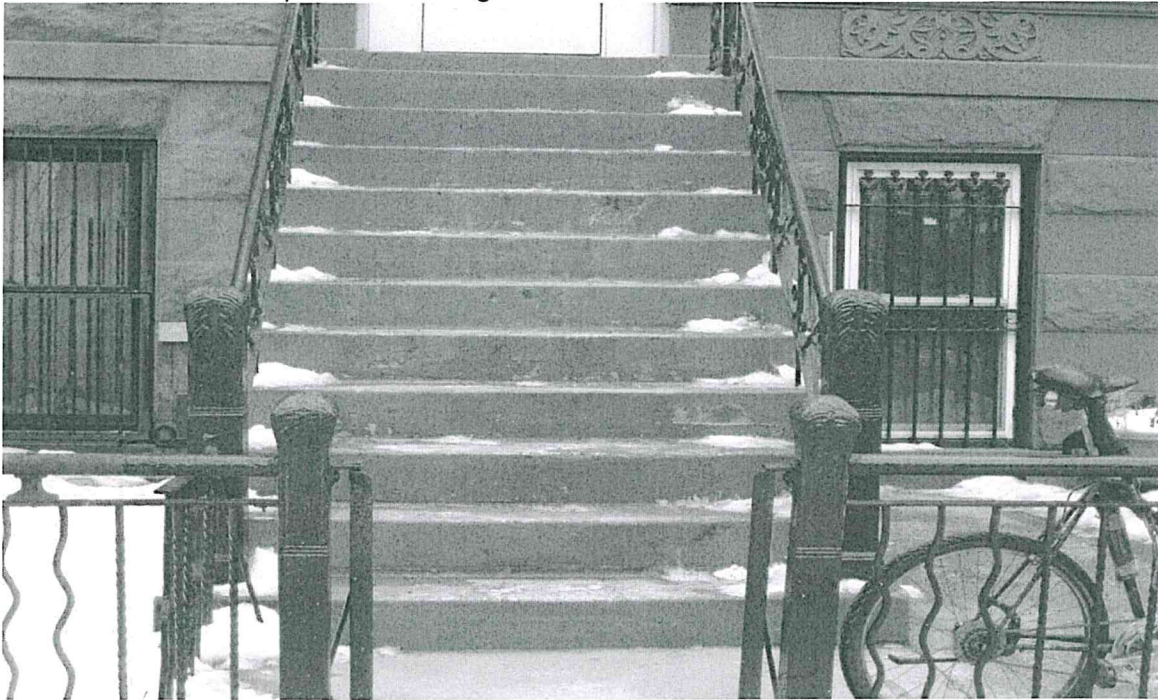
Photo 7

View of the front stoop of the building.

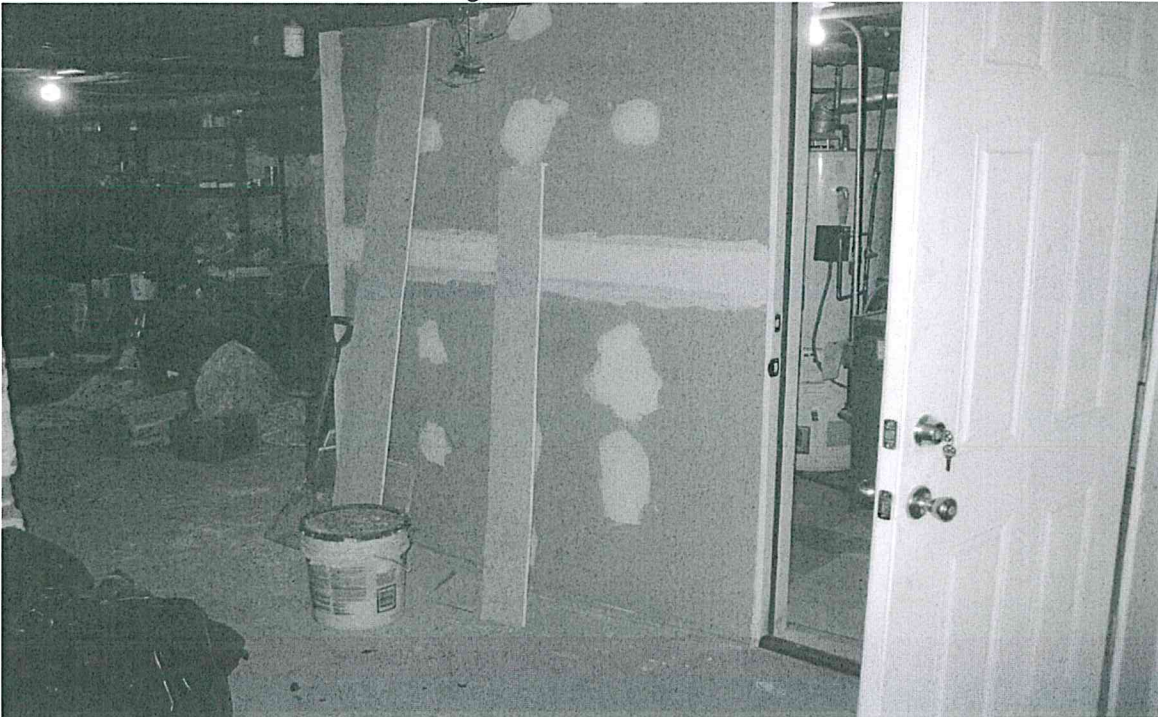
Photo 8

View of the basement of the building.

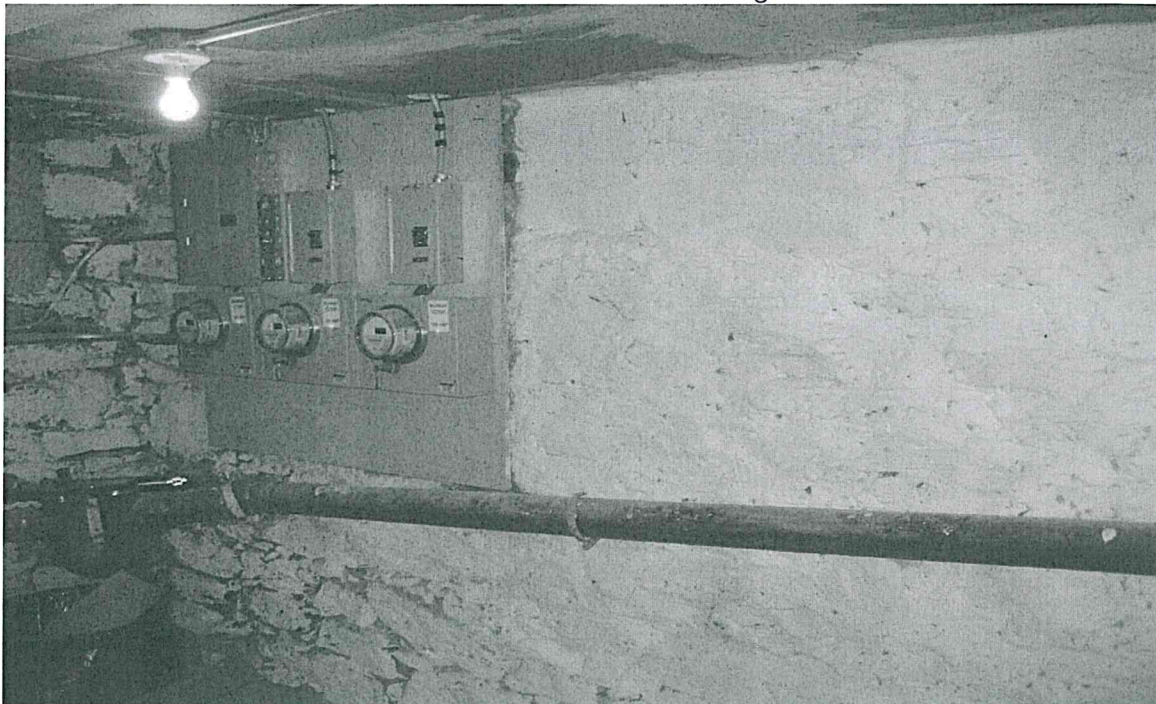
Photo 9

We inspected the foundation of the building in the basement and around the exterior perimeter of the building. The stone foundation wall was visible and accessible in the basement and we were able to evaluate its structural condition. The stone foundation wall was re-pointed with cement mortar and interior face was painted. We did not observe any evidence of structural cracks, shift, bow or structural deflection in the foundation wall. The stone foundation wall was found to be in overall satisfactory condition.

View of the foundation wall in the basement of the building toward the northeast corner.

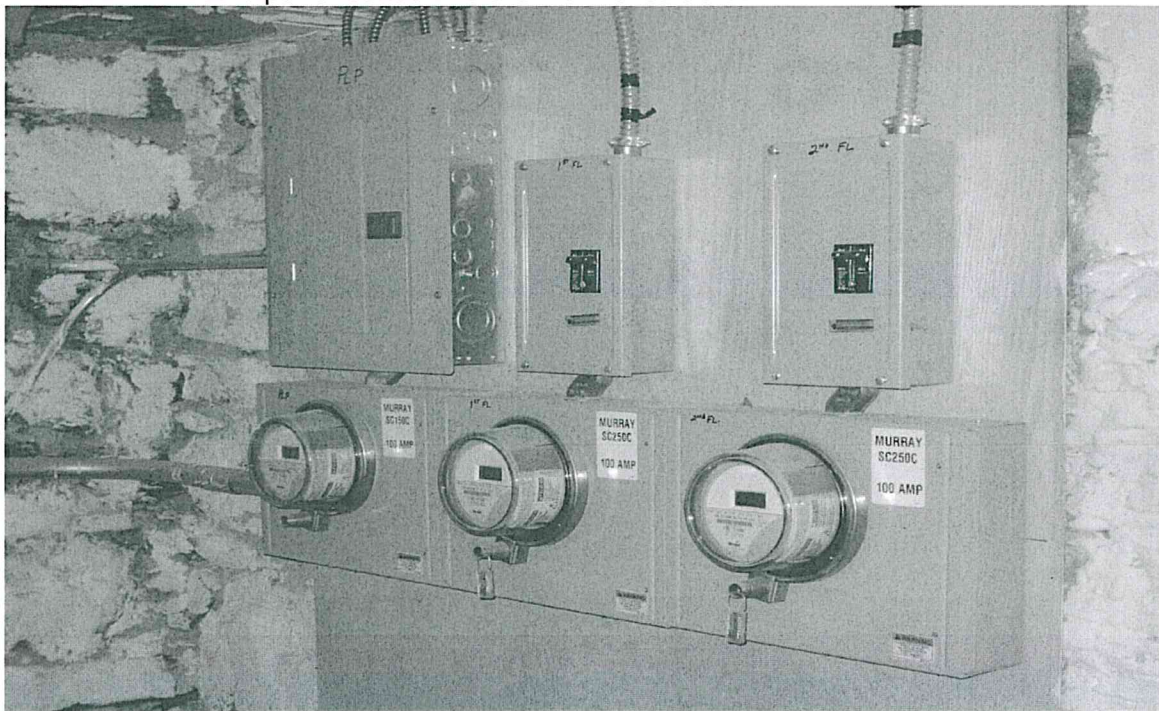
Photo 10

We inspected the electrical system of the building in the basement and throughout the building. We observed new electrical wirings, panel boxes, outlets, switches, lights and the entirely new system. It appears that the electrical system of the building was replaced in 2011. There were three (common area, first family and second family) electrical meters and panel boxes in the basement. The electrical capacity for each family house was 60 amps and the panel box for the ground level apartment was branched out of the common area panel box. The electrical system, wiring and the entire electrical components of the building had been replaced during the past 5-10 years. The electrical system of the building were found to be in overall satisfactory condition and constructed as per the engineering and construction industry design standards.

View of the electric panel boxes and the main circuit breaker boxes.

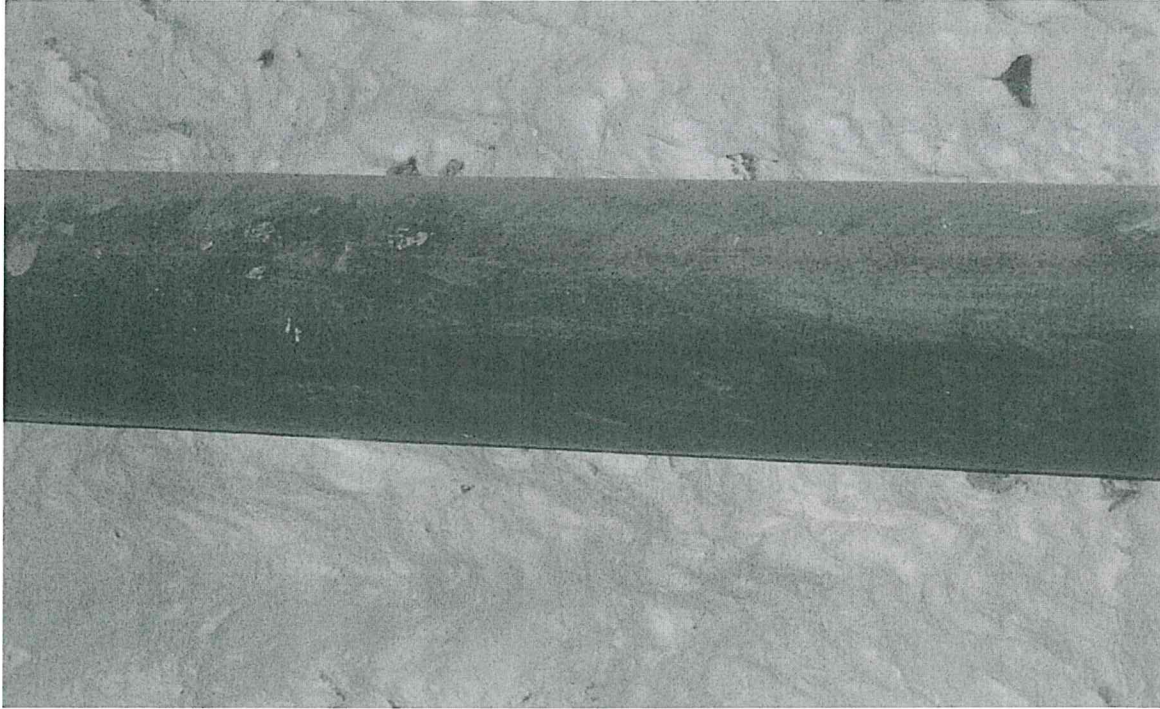
Photo 11

View of the new cast iron waste pipe in the basement along the east foundation wall.

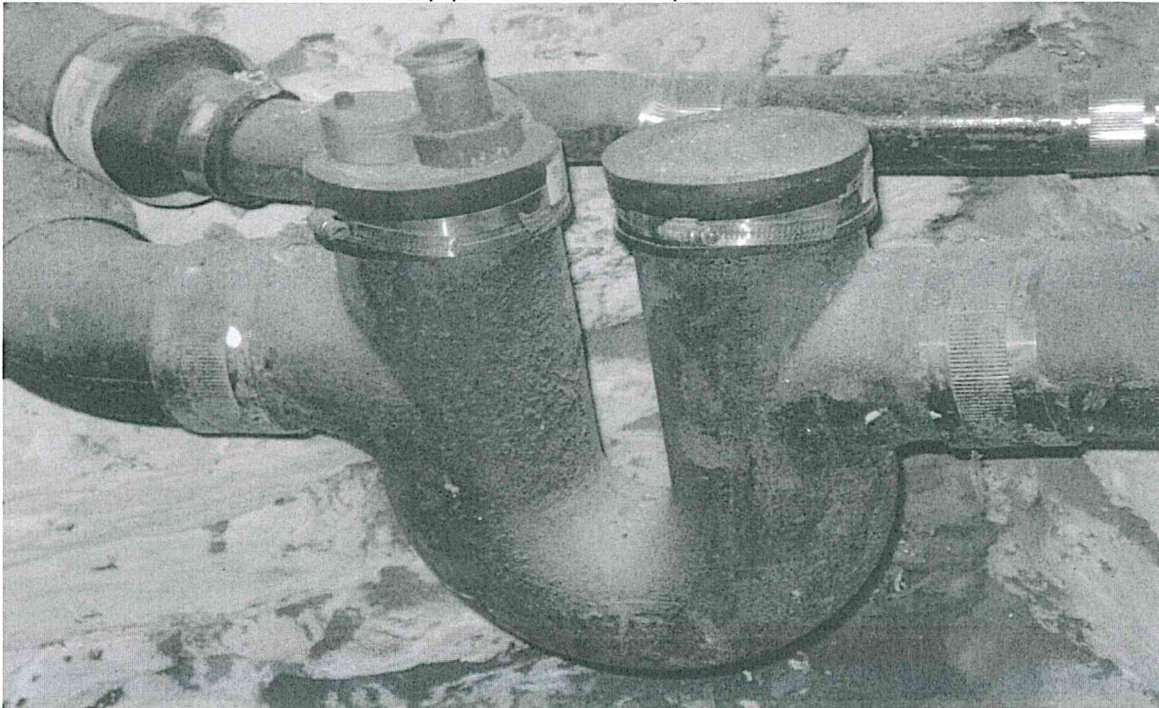
Photo 12

View of the new cast iron waste pipe and sewer trap in the basement.

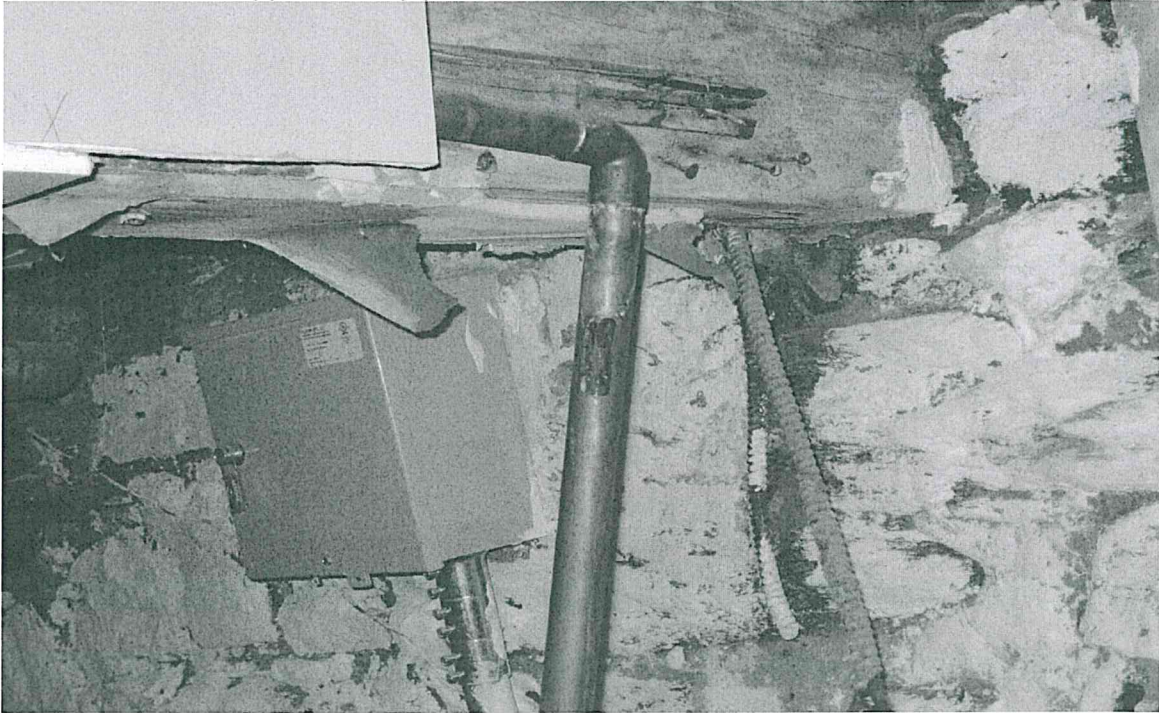
Photo 13

View of the new copper water pipe in the basement.

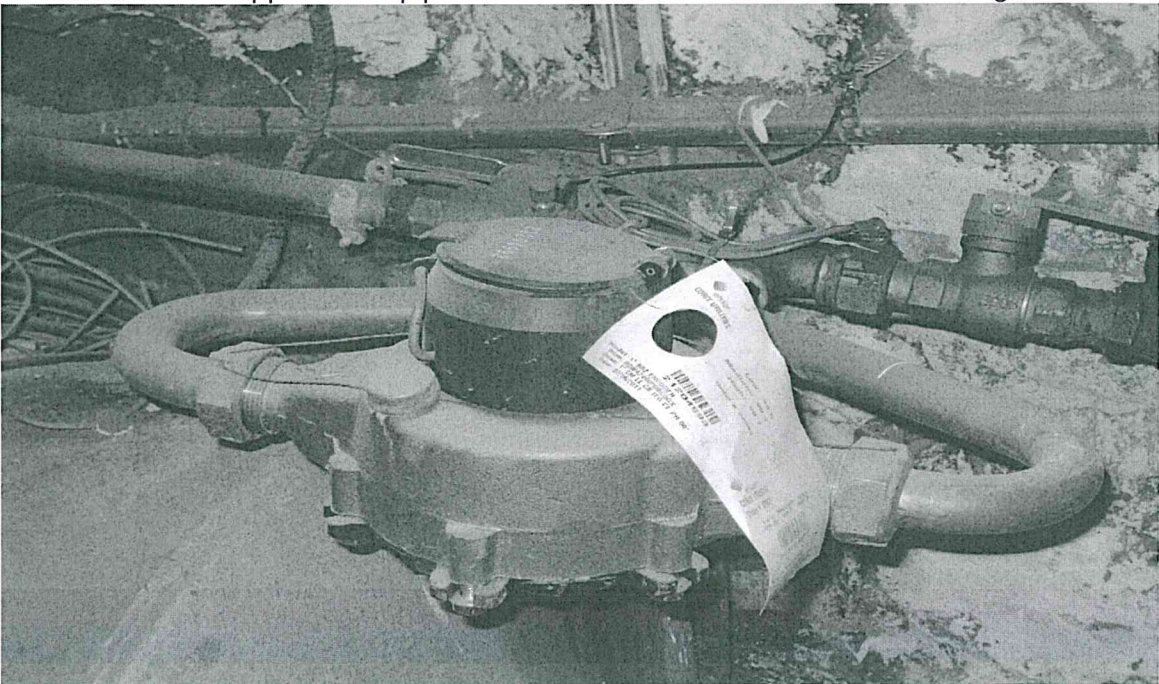
Photo 14

View of the new copper water pipe and meter in the basement of the building.

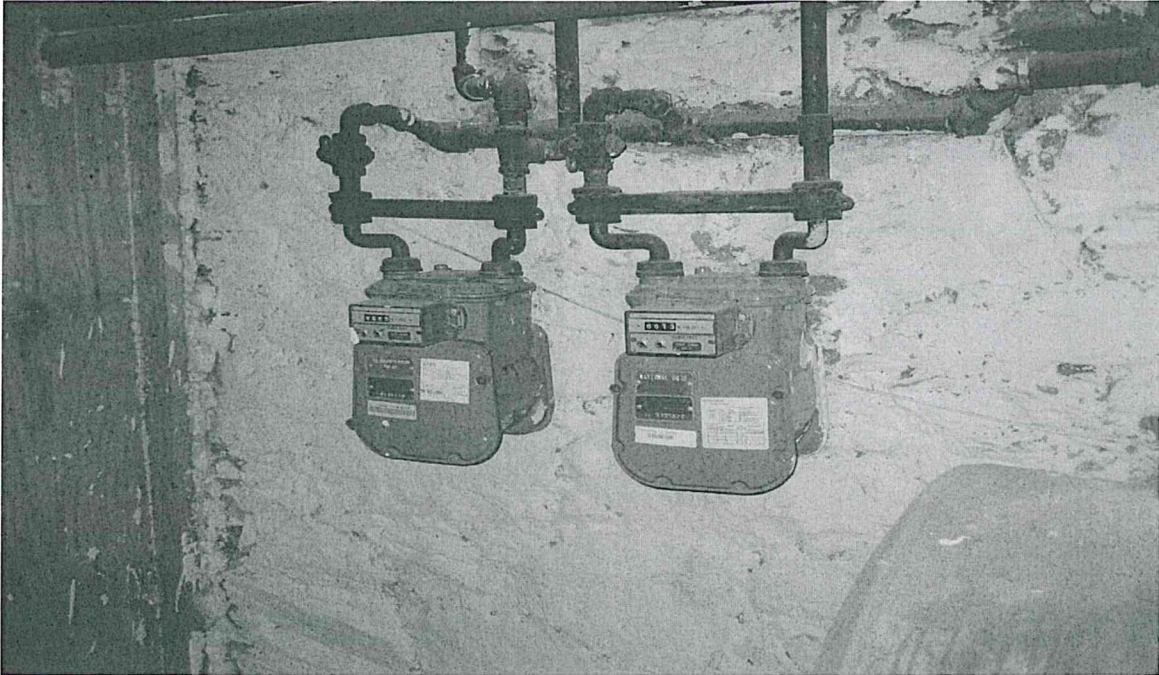
Photo 15

View of the gas meters and gas pipes in the basement of the building.

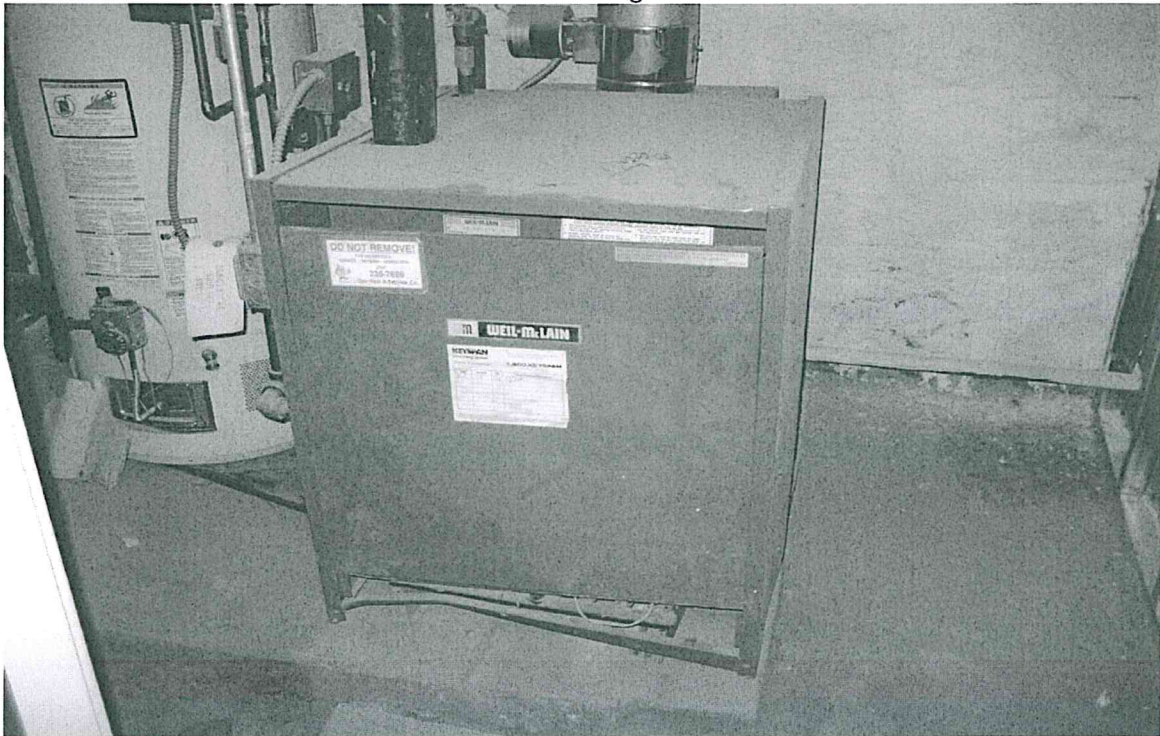
Photo 16

The heating system of the building was hot steam radiator system. The heating unit was Weil McLain brand, cast iron base,

gas fired, approximately 5-8 years old and in satisfactory condition. The heating unit, the heat pipes, the radiators and the entire heating system of the building were inspected and found to be in overall satisfactory condition and constructed as per the engineering and construction industry design standards.

View of the boiler in the basement of the building.

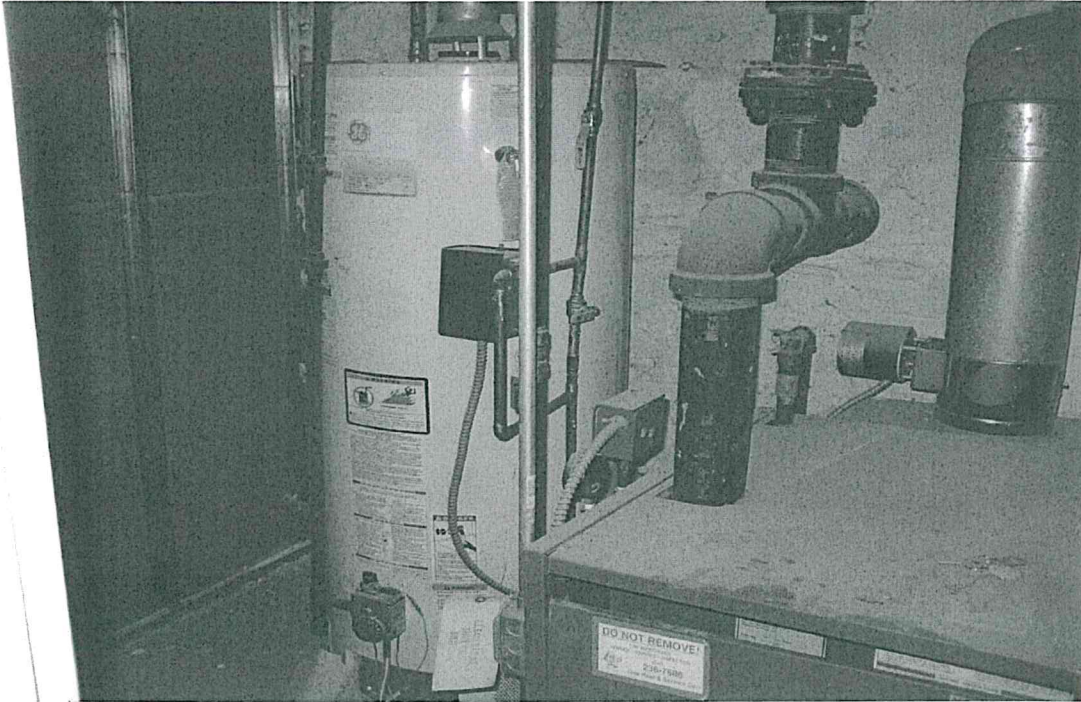
Photo 17

View of the hot water heater in the boiler room in the basement.

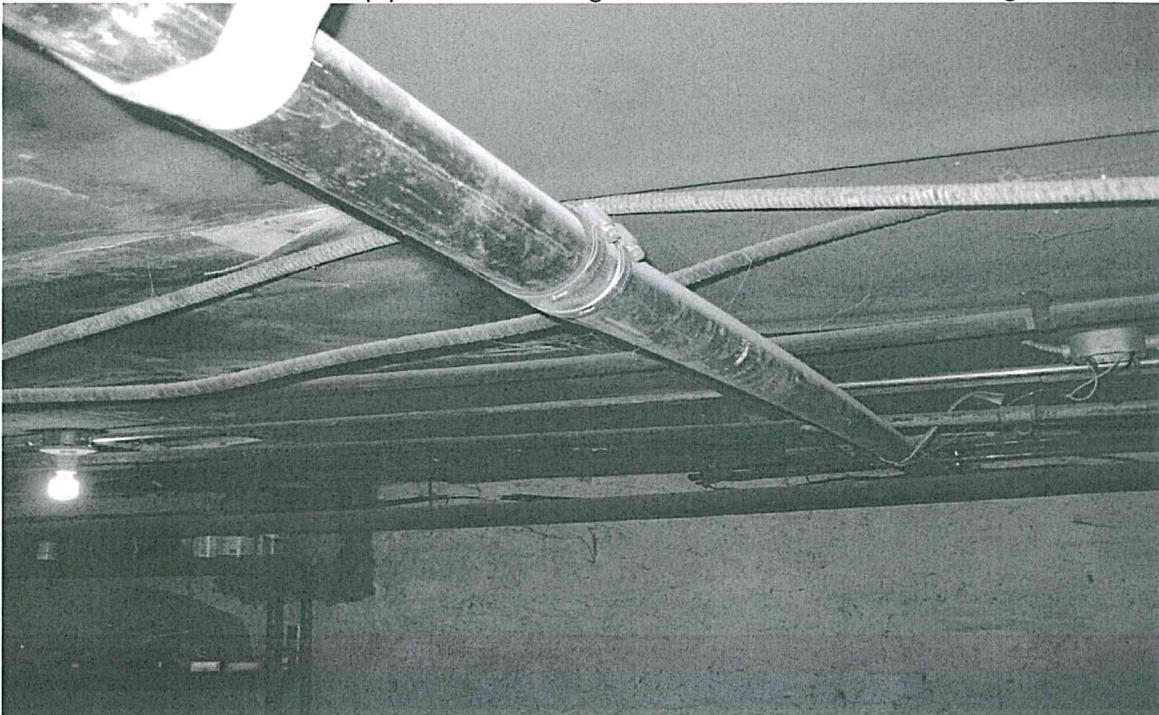
Photo 18

View of the cast iron waste pipe on the ceiling of the basement of the building.

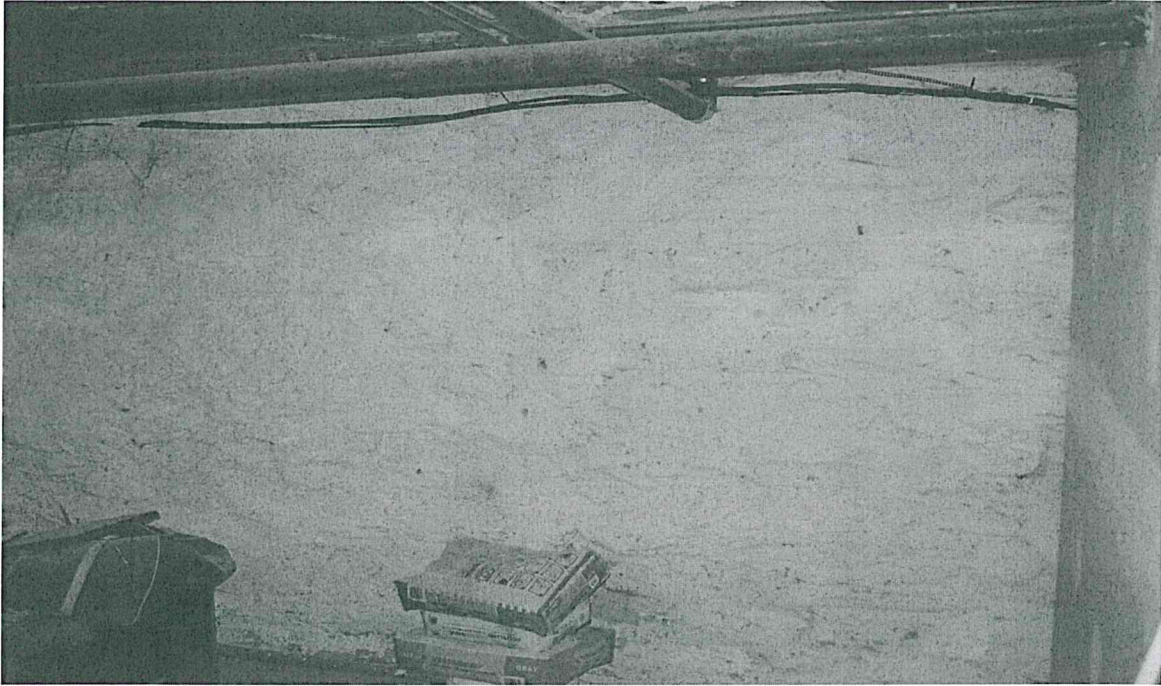
Photo 19

View of the west foundation wall in the basement of the building.

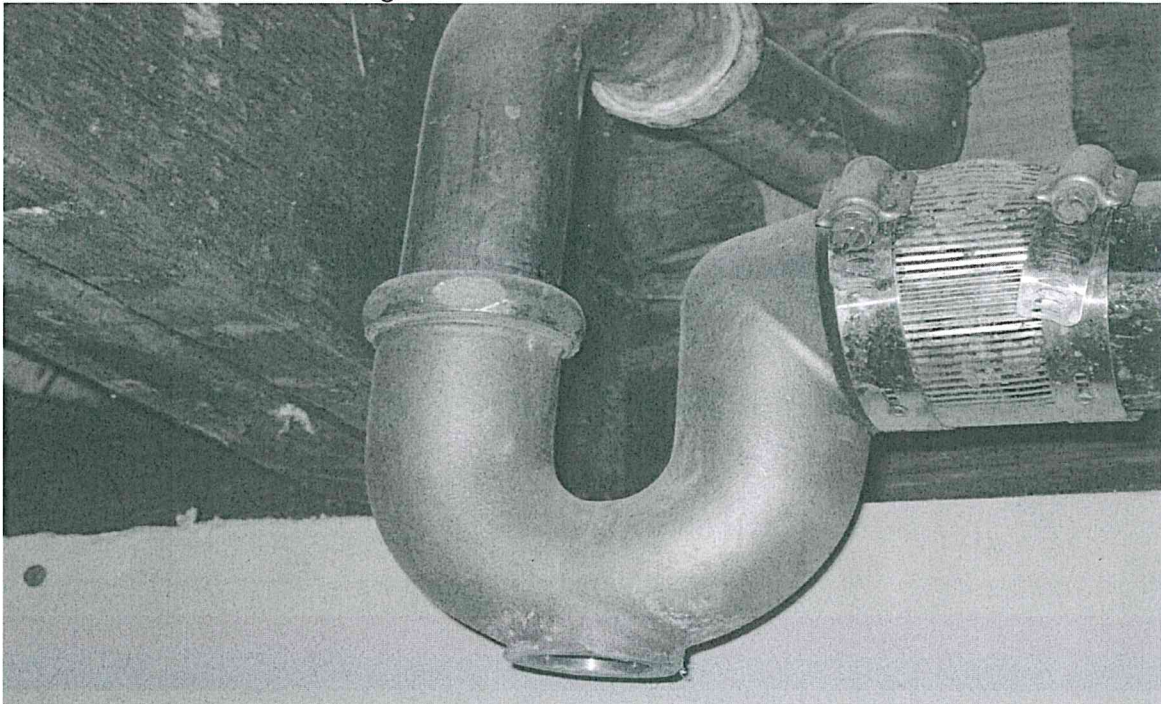
Photo 20

View of the new brass waste pipe trap on the ceiling of the basement along the east foundation wall of the building.

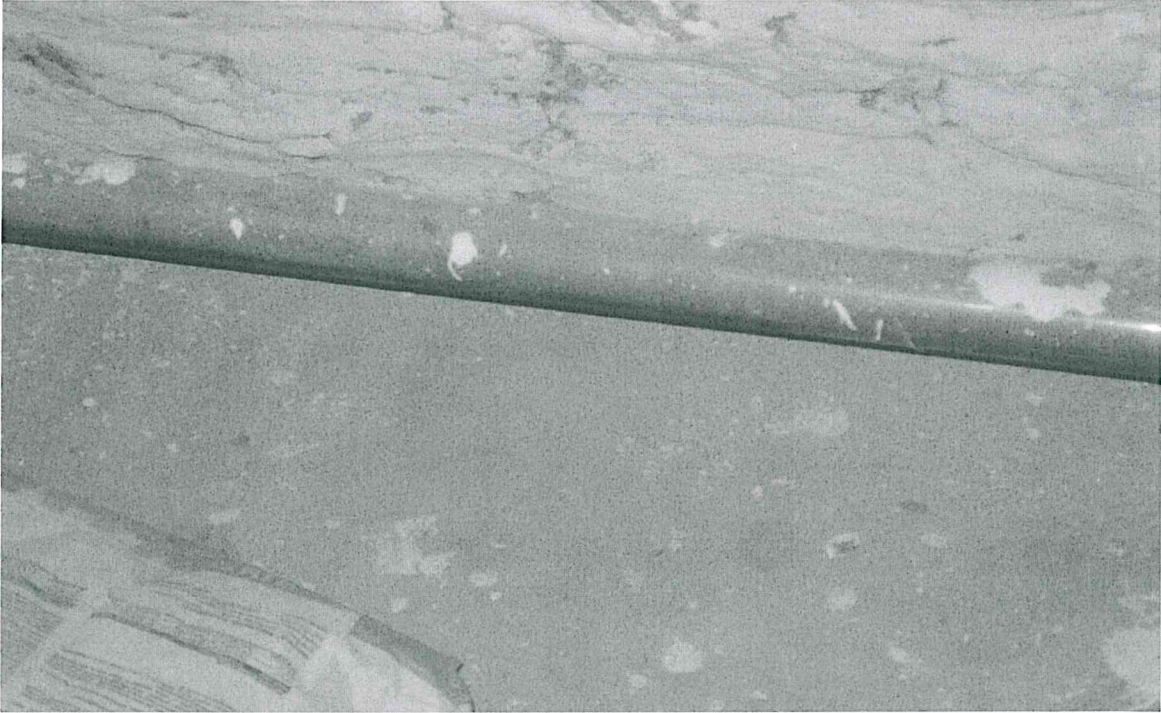
Photo 21

View of the new copper return heat pipe on the basement floor along the foundation wall.

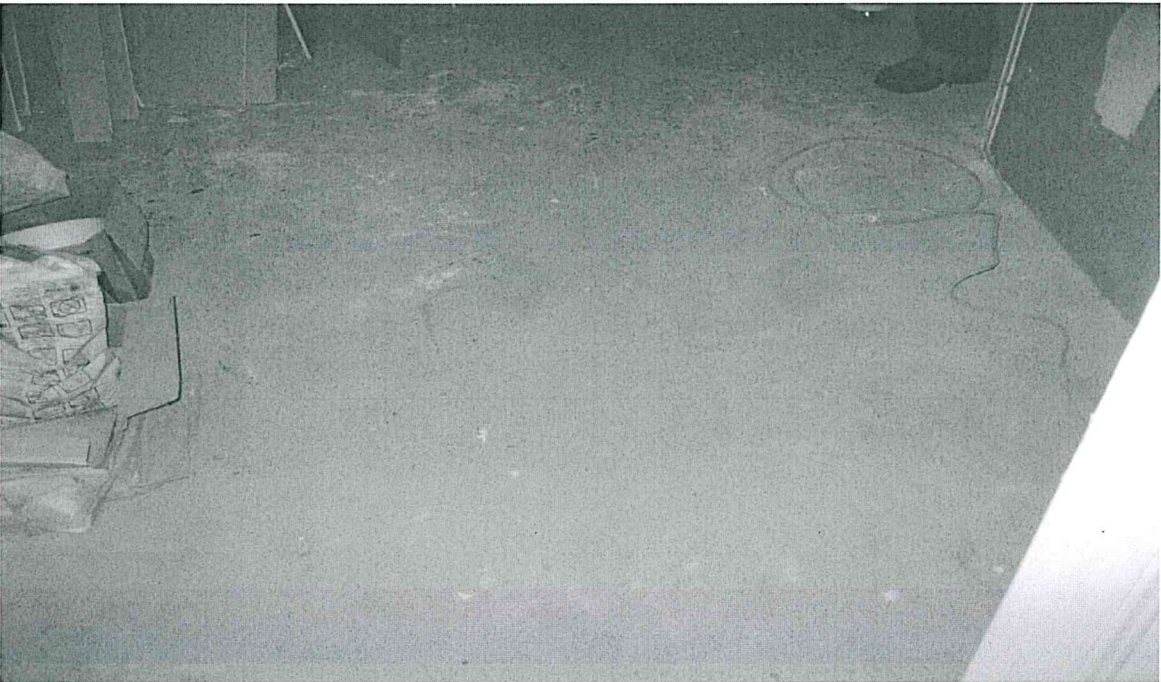
Photo 22

View of the basement floor.

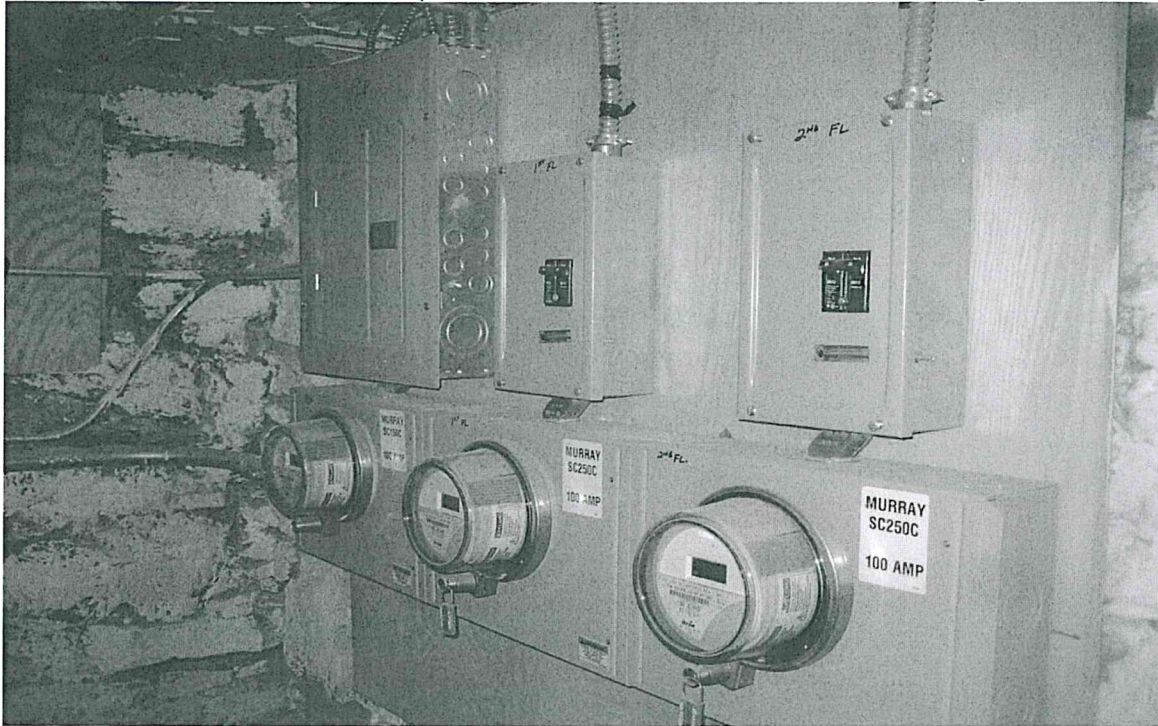
Photo 23

View of the electric meters and panel boxes in the basement of the building.

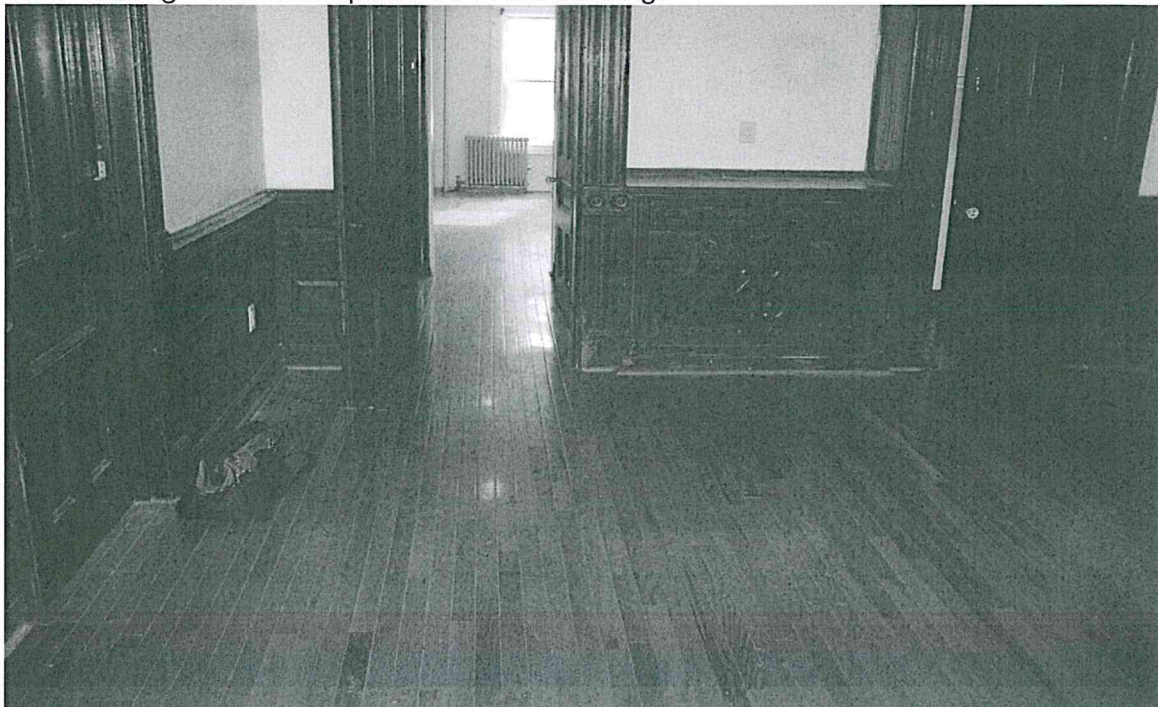
Photo 24

View of the ground level apartment of the building.

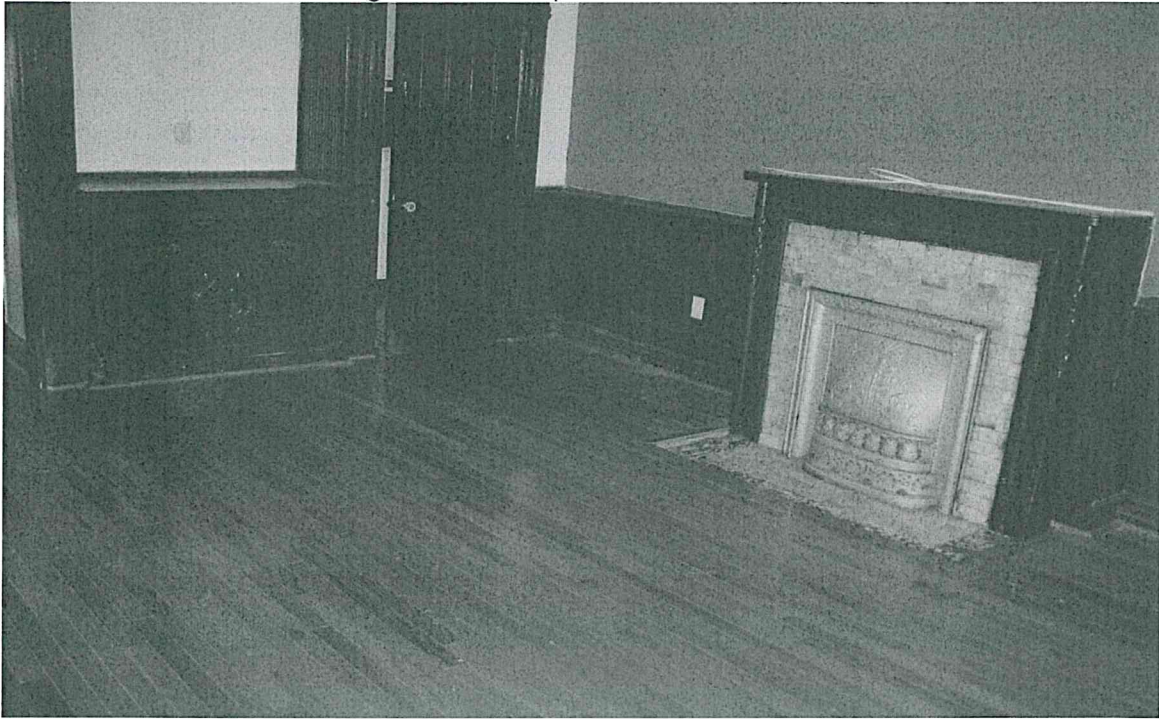
Photo 25

There is one bedroom in the ground level apartment. We inspected the bedroom of the apartment. The floor covering was hardwood floor and in satisfactory condition. The wall and ceiling covering were drywall material and were installed in 2011. The new drywall were installed over the old plaster walls and ceiling. The old walls and ceiling were properly encapsulated by installing the new drywall over the old surface. The drywall wall and ceiling coverings were found to be in overall satisfactory condition and were constructed as per the engineering and construction industry design standards.

View of the bedroom of the ground level apartment.

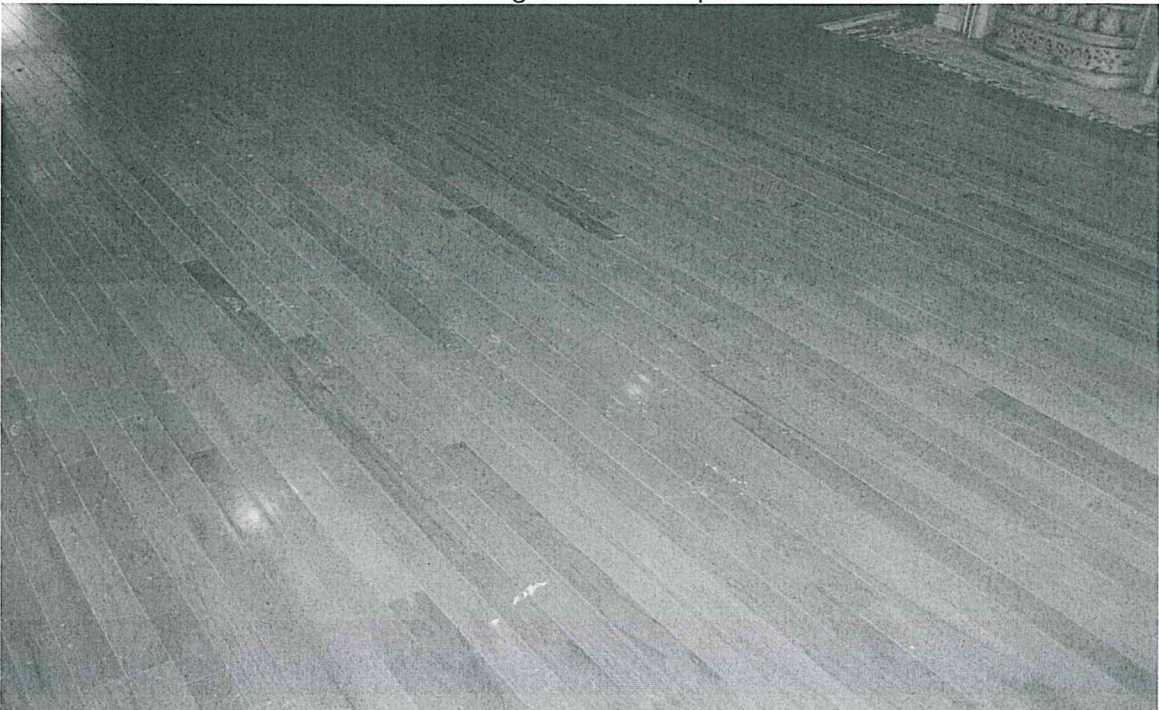
Photo 26

View of the floor of the bedroom in the ground level apartment.
